# Example Investigations

Representative Materials Failure Analysis & Characterization Examples

# Adhesive Bond Failure Investigation

# Premature Elastomer Cracking Investigation

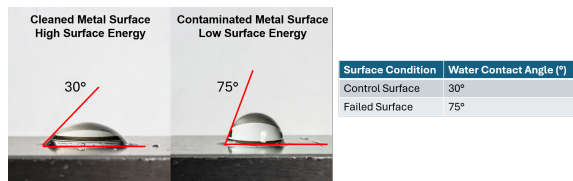
Elemental mapping revealed localized silicon-rich regions at the failed bond interface that were absent in control specimens. FTIR identified the contaminant as polydimethylsiloxane (PDMS), consistent with silicone-based release agents.

FTIR spectrum identifying silicone residue

- Eliminate silicone-containing materials from upstream handling and molding processes.
- Implement line-side water contact angle screening prior to bonding.
- Standardize surface cleaning and preparation procedures.

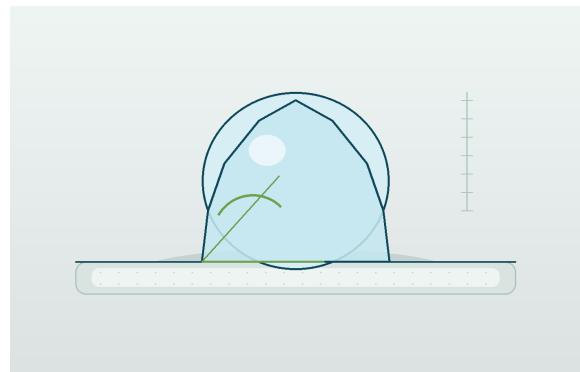
Surface energy / contact angle comparison

The likely failure mechanism was adhesion loss caused by silicone contamination on the bonding surface. The residue lowered surface energy, prevented proper adhesive wetting, and created a weak boundary layer that propagated under thermal and humidity cycling.

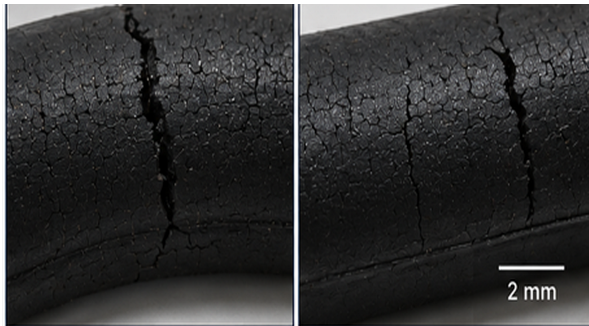
Cracking pattern and service context

Fine surface cracks were observed perpendicular to the applied strain direction, a pattern consistent with ozone attack. FTIR identified the material as natural rubber, an unsaturated elastomer with limited long-term ozone resistance.

- Replace natural rubber with ozone-resistant EPDM where appropriate.
- Update material specifications to include ozone exposure requirements.
- Add accelerated ozone testing to qualification protocols.
- Implement supplier material verification requirements.

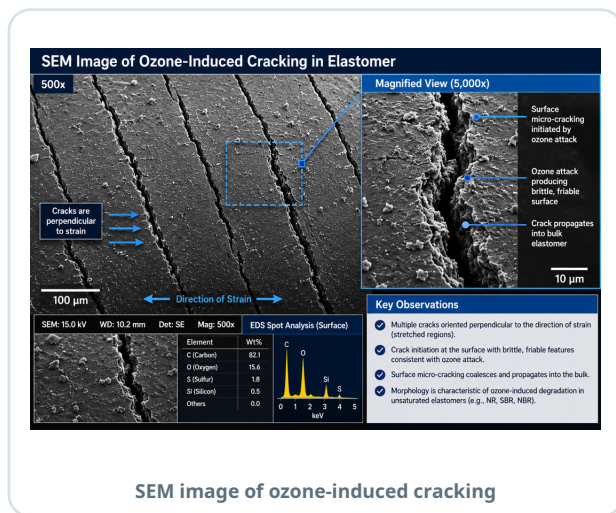
SEM image of ozone-induced cracking

The likely mechanism was ozone-induced degradation of an unsaturated elastomer that lacked adequate outdoor resistance. Atmospheric ozone attacked double bonds in the polymer backbone, causing chain scission and progressive surface cracking.

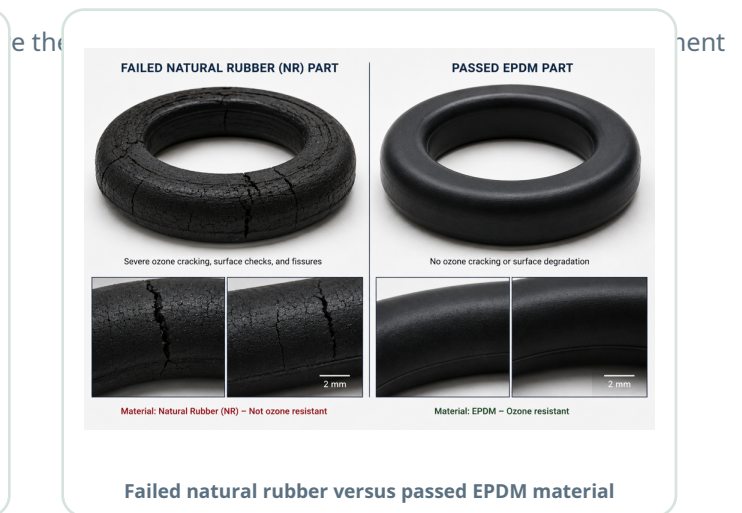
Failed natural rubber versus passed EPDM material

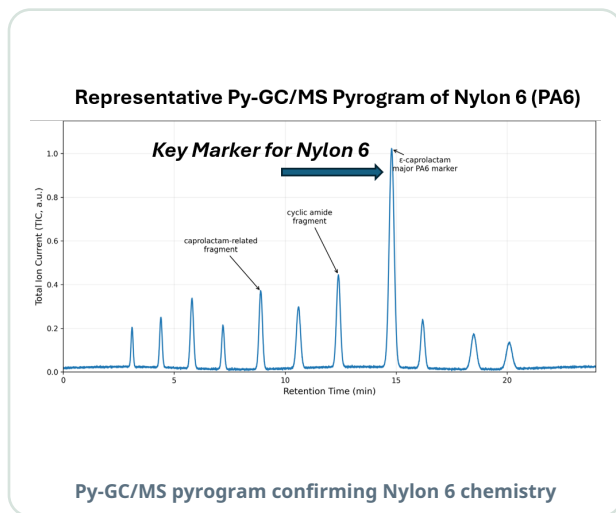
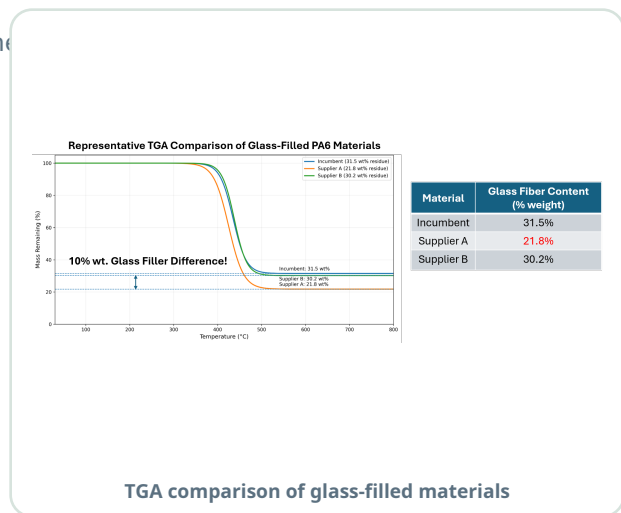
FTIR identified the material as a polyamide. Py-GC/MS confirmed Nylon 6 chemistry, while TGA and SEM/EDS revealed meaningful differences in glass fiber reinforcement between the incumbent and candidate suppliers.

One candidate material was not compositionally equivalent despite similar supplier descriptions. Lower reinforcement content and formulation differences would likely reduce mechanical performance and durability.

- Establish analytical acceptance criteria for incoming materials.
- Qualify alternative suppliers based on objective equivalency data.
- Add FTIR verification for critical components.
- Document material composition for future procurement decisions.
