# Example Investigations

Representative Materials Failure Analysis & Characterization Examples

# Adhesive Bond Failure Investigation

# Premature Elastomer Cracking Investigation

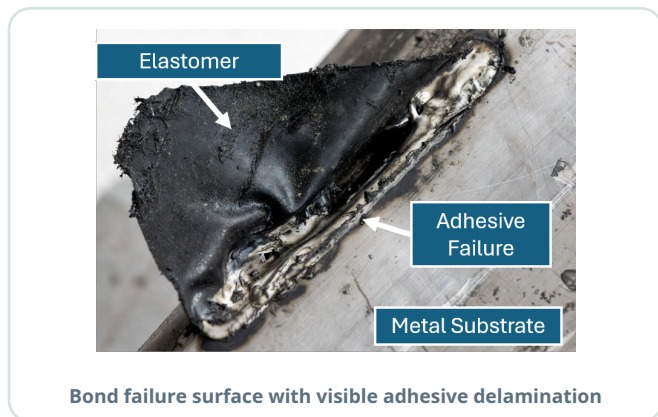
Elemental mapping revealed localized silicon-rich regions at the failed bond interface that were absent in control specimens. FTIR identified the contaminant as polydimethylsiloxane (PDMS), consistent with silicone-based release agents.

The likely failure mechanism was adhesion loss caused by silicone contamination on the bonding surface. The residue lowered surface energy, prevented proper adhesive wetting, and created a weak boundary layer that propagated under thermal and humidity cycling.

Even trace silicone contamination can cause premature adhesive failure. Routine surface energy verification is an important quality control step for elastomer-to-metal bonding.
